## UNION CITY RESERVOIR DAM

NDI No. PA 00019  
PennDER No. 25-3

## PHASE I INSPECTION REPORT NATIONAL DAM INSPECTION PROGRAM

May 1979

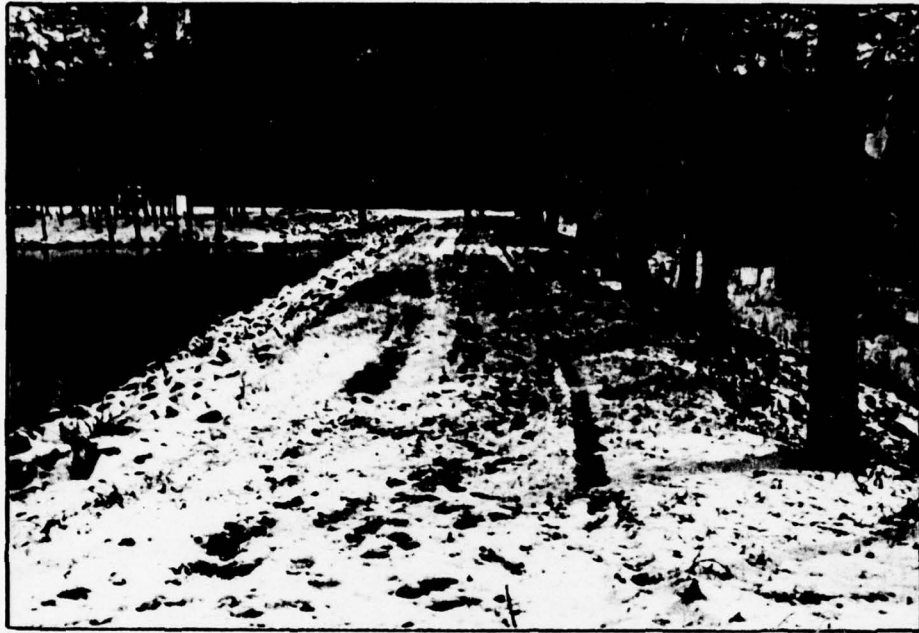
- 7) The clay puddle core is exposed at the bottom of ruts along the crest. These ruts appear to be the result of vehicular traffic.
- c. Appurtenant Structures - Minor spalling and cracking was noted along the outlet head wall and wing walls, also some pitting and cracking was observed on the 24-inch blow-off pipe. The inspection team was informed by operating personnel that the 24-inch blow-off pipe is never operated. The

**PHOTO 1. View from Right Abutment (Note Clay Puddle Core Exposed by Ruts along Top of Crest and Trees along Downstream Edge of Crest)**

- 2) The trees along the crest of the dam should be removed. Prior to the removal of these trees, however, it would be advantageous for the owner to initiate a study concerning the potential problems associated with their removal and to obtain qualified recommendations as to the best method of removal that would produce minimal damage to the embankment. Also, the downstream slope area should be cleared and grubbed for a distance within 10 feet of the toe.

- 2) The exposed clay puddle core along the dam crest should be graded, treated and seeded with an appropriate seeding mixture to prevent erosion.
- 3) All rodent holes along the embankment should be properly repaired.
- 4) The spalled and cracked concrete on the outlet structure should be repaired as necessary.

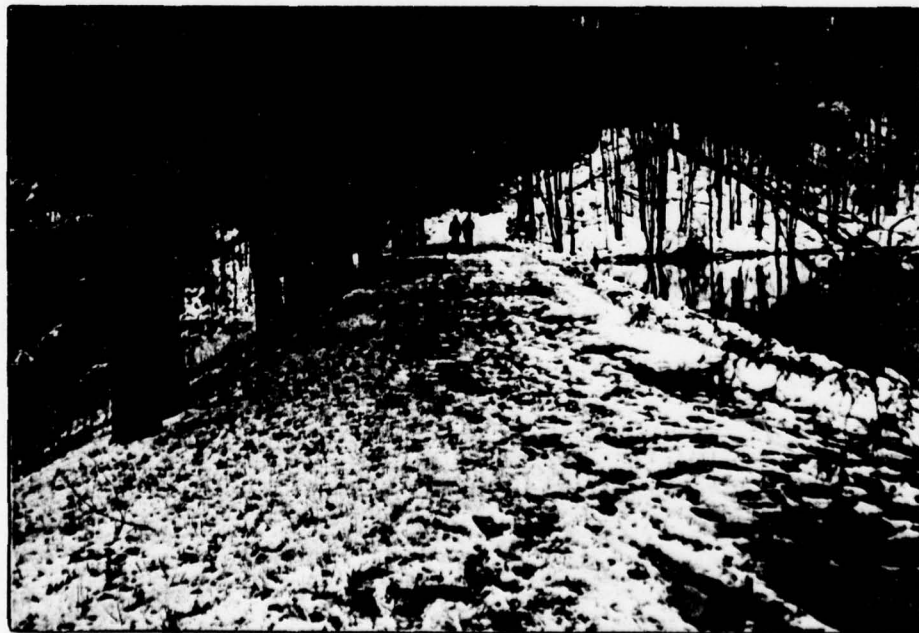
**PHOTO 2. View from Left Abutment**

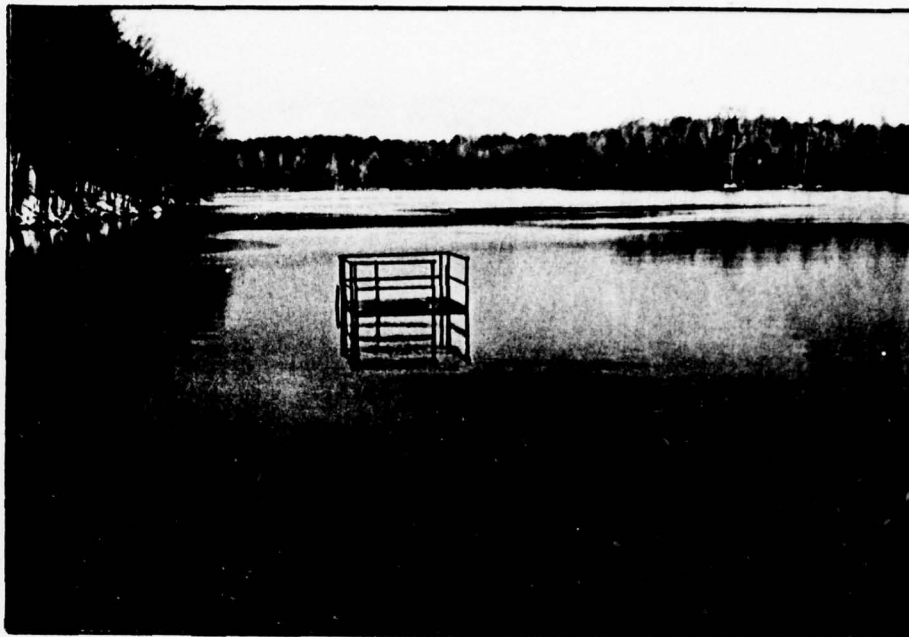
**PHOTO 3. View from Crest of Dam Looking Upstream Showing  
Top of Gate Valve House**

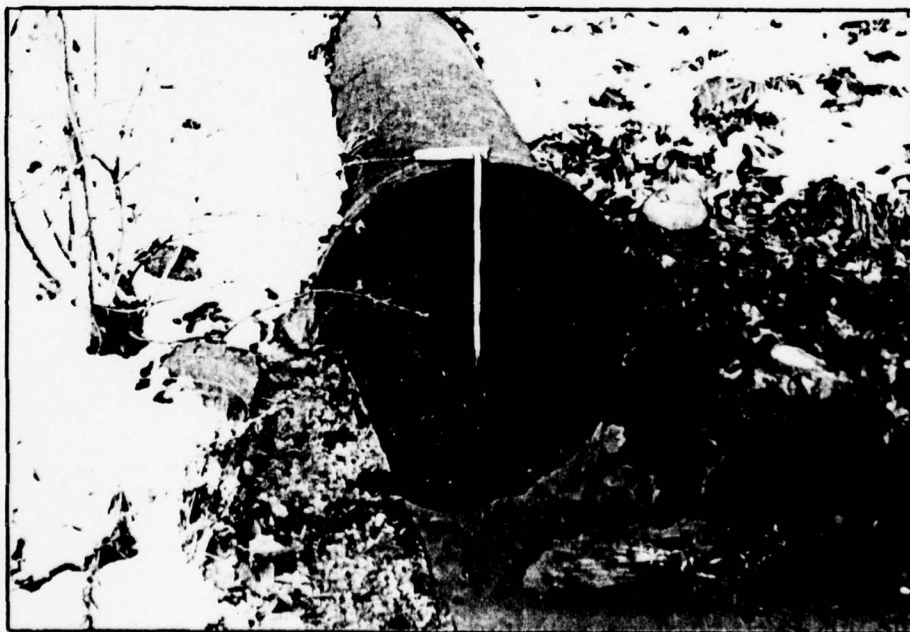
**PHOTO 4. View of 24-inch Blow-off Pipe Showing "V" Notch Weir**

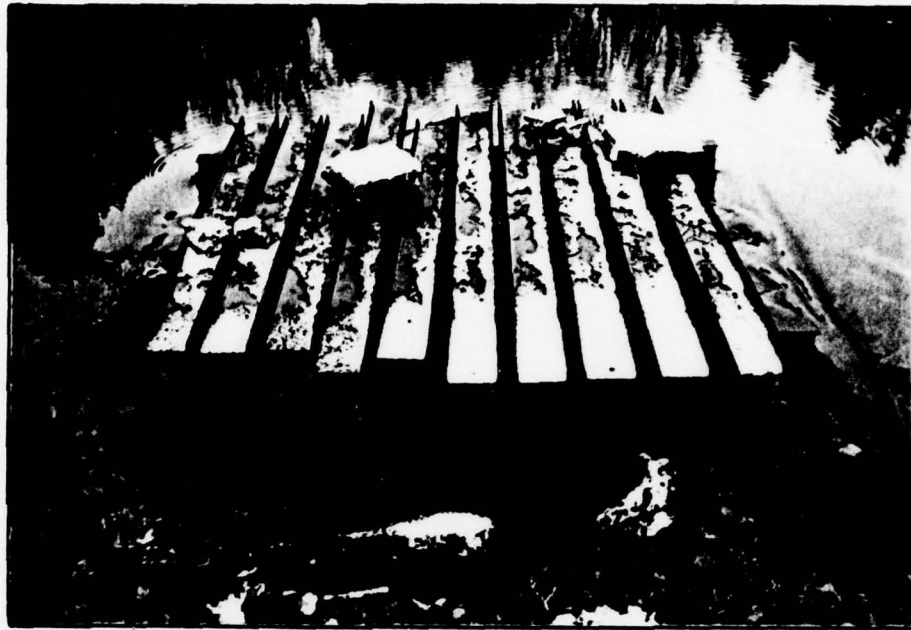
**PHOTO 5. View of Concrete Overflow Weir Box**

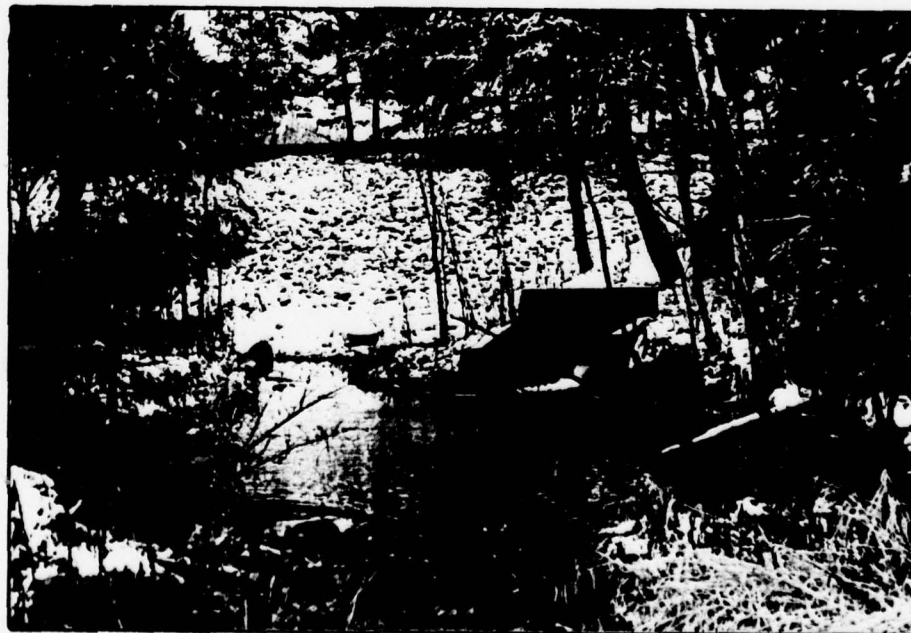
- 3) Erosion was noted along the left wing wall of the outlet pipe.
  - 4) Several trees and large bushes are growing on the downstream embankment near the toe.

**PHOTO 6. View of Outlet Pipe for Weir Box  
(Note Trees Growing above Head Wall on Downstream Embankment)**

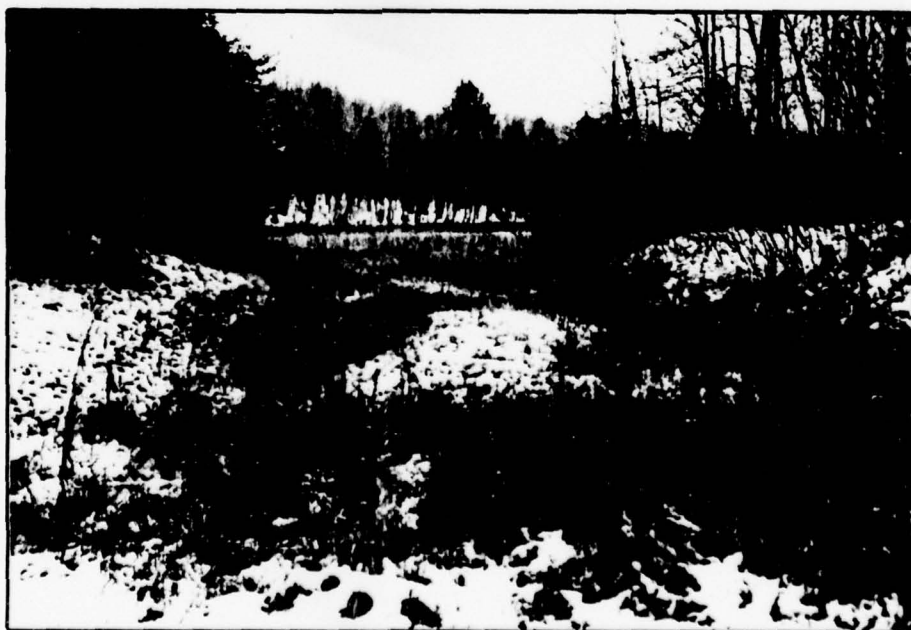
**PHOTO 8. View of Emergency Spillway Approach Channel**
